Replacement gravel caisson Cadzand, Breskens, NL

Location: Cadzand, the Netherlands
 Project owner: Waterschap Zeeuws Vlaanderen
 Date: 2006
 Product type: Findrain 5006H

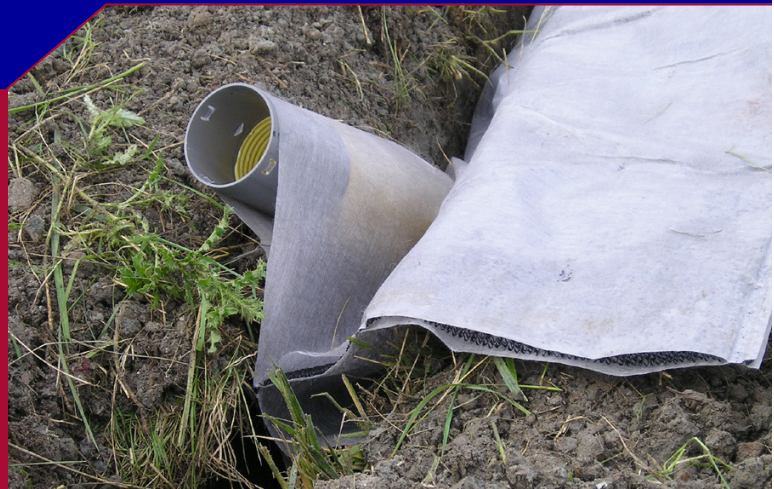
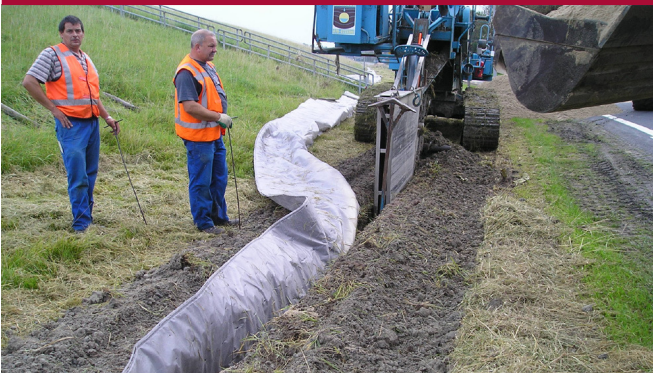
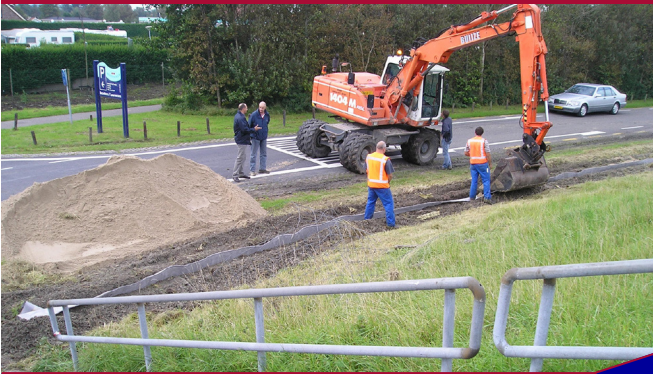
Waterschap Zeeuws Vlaanderen opted to replace the drain caisson along this section with Findrain 5006H. This is a thin, pressure-stable drainage mat into which a pipe can be fitted. Nozzles can also be attached to the tube. Findrain is installed at a depth of around 70 cm and removes the excess water quickly and easily.
