Long term efficiency of erosion control geomats

Keywords: geomats, long term efficiency

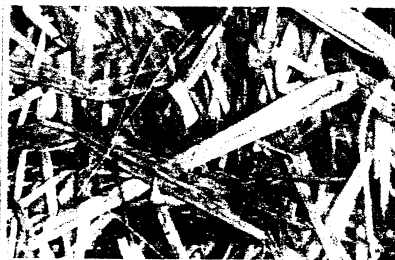
Figure 1. Example of biomat.

Erosion is part of the natural phenomena of abrasion and soil entrainment. These phenomena are usually due to wind and water sometimes influencing the soil balance with disastrous effects. For such reasons the correct design of any work in contact with soil requires a valuation of the potential erosion risk and, if necessary, the choice of the suitable protection interventions. Each adopted solution must be proportional to the potential risk in order to grant the intervention to be effective and meanwhile to avoid unnecessary expense in a correct costs-benefits connection. Therefore, there are different technical solutions with different materials orienting towards various problems of erosion to face. In the erosion prevention interventions of the slopes or channels where the energies are not particularly strong, one of the most widespread techniques involves the laying of natural (biomats) or synthetic (geomats) materials onto the soil. The biomats (Figure 1) are used where

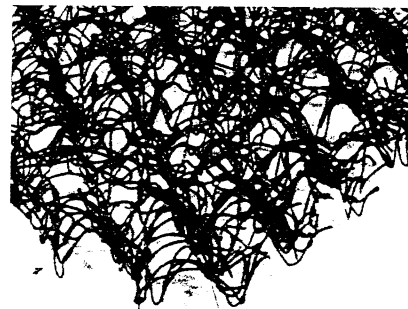
The erosion prevention geomats (Figure 2) are lightweight structures which are usually between about 10 and 20 mm thick. They are generally made of

Figure 2. Example of geomat.

synthetic polyamide or polypropylene filaments welded together to form a three-dimensional matting structure with a high level of free space (higher than 90-95%).

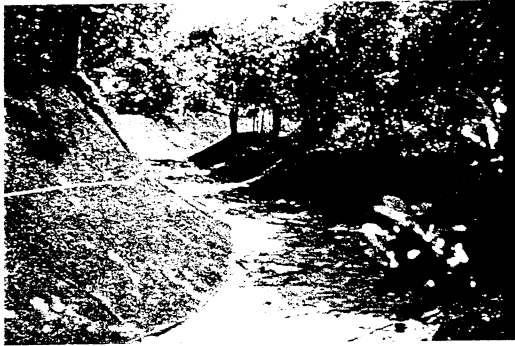
The intervention carried out on the Farinella stream dates back to 1988. The stream presents a regular section with a bottom about 2 m wide and banks of a varying range between 2 and 3 m high with an average gradient of 35°. The design solution planned the laying of an asphalted geomat onto the bottom and of a geomat filled in with soil for the banks (Figures 9 and 10). Both were fixed onto the soil by iron pins. During the survey in November 2003 it was observed that the intervention was completely effective since there was a good vegetation blanket on the banks.

Figure 9. At the end of construction.

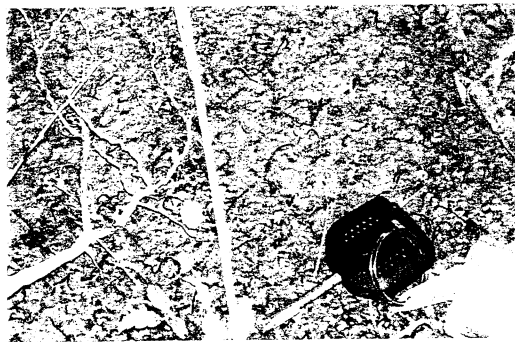
When testing the bottom, the geomat could be seen to be perfectly complete. In particular over the bottom there were: areas of material storage where the geomat was covered with 5-10 cm of soil and areas at high energy water flow where the geomat efficiency to prevent erosion effects was particularly evident (Figure 11).

Figure 11. Stretch of stream without vegetation where the geomat 23 years old prevent erosion.

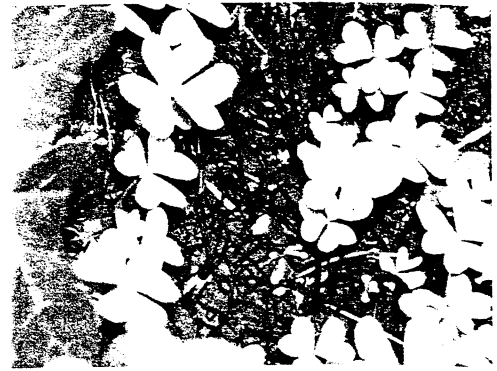
On the whole, the banks prevented were visible stable and with vegetation. In one tract where the gradients of the slopes reach 45° clear traces of a recent fire were found. Through a careful examination of some geomat tracts which were laid bare, it was possible to observe that, although superficially involved in the fire, the geomat was not burnt thanks to the autoextinguishing property of the polyamide. It had also kept at the same time its three-dimensional structure (Figure 12).

Figure 12. Geomat superficially involved in the fire.
