**Environmentally-friendly banks,  
Lake Lauchhammer**

Location: Lauchhammer/  
Schwarzheide (Germany)  
Contractor: NSG Freienhufen  
Date: July 2007  
Product type: Enkamat A20  
Quantity: 2,300m<sup>2</sup>

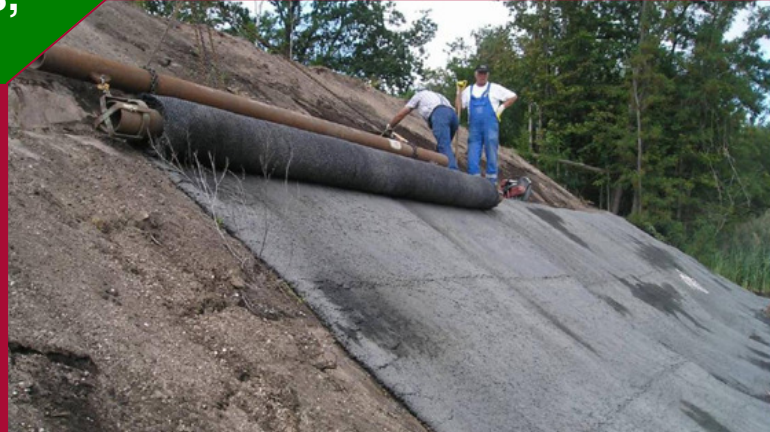
Above: Eroded slope before installation of Enkamat A20

At a reservoir between Lauchhammer Ost and Schwarzheide, the bank on the southern side was suffering erosion. Due to the mainly sandy soil and the southern location, the bank was particularly vulnerable to erosion from rain and wind.

The bank has a gradient of 1:1.5 and is approximately 12m long. The pumps used in the reservoir mean the water levels can fluctuate considerably. The bank therefore was very vulnerable at the water line.

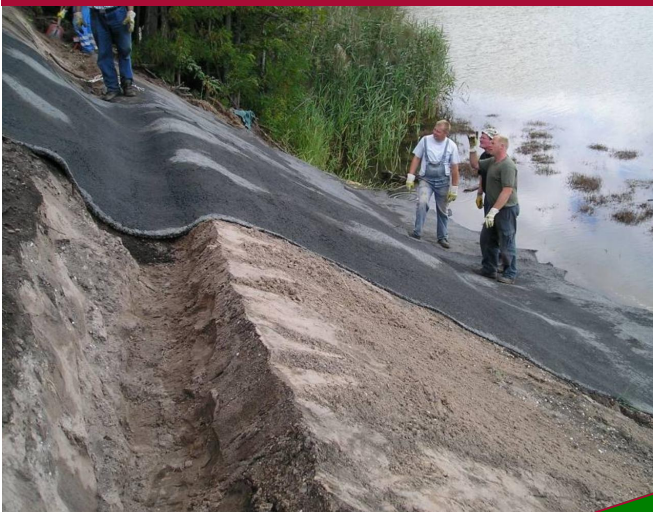
The bank was levelled, stabilized and sown before the mats were laid, working from the bottom of the bank upwards. Each strip ended in a channel so that excess drainage water could not cause any erosion behind the mats. The mats were fixed in place using pins. The first greenery appeared on the mats after just a couple of weeks and within a year, Enkamat A20 was completely covered and no longer visible.
