**Reconstruction river embankments  
South Korea**

Location: South Korea  
 Project owner: Local Government  
 Date: 2009  
 Product type: Enkamat® 7018

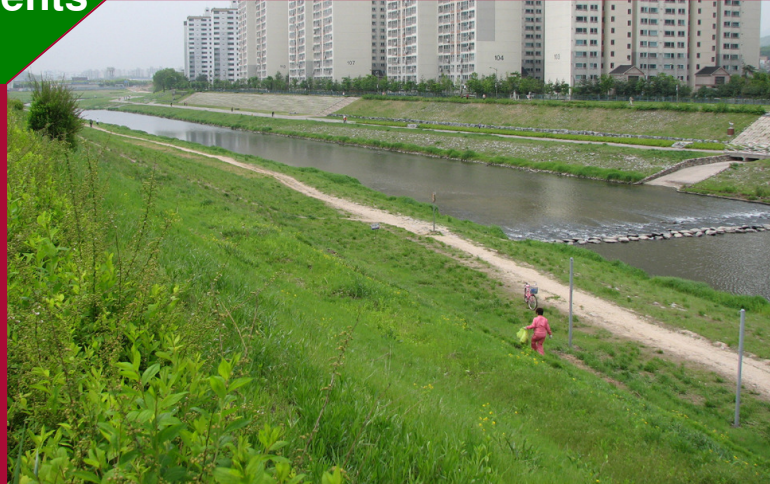
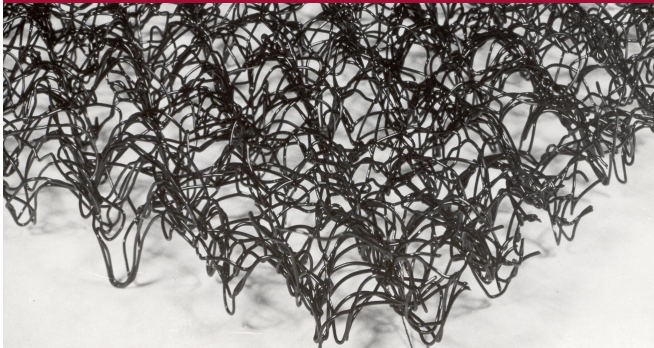
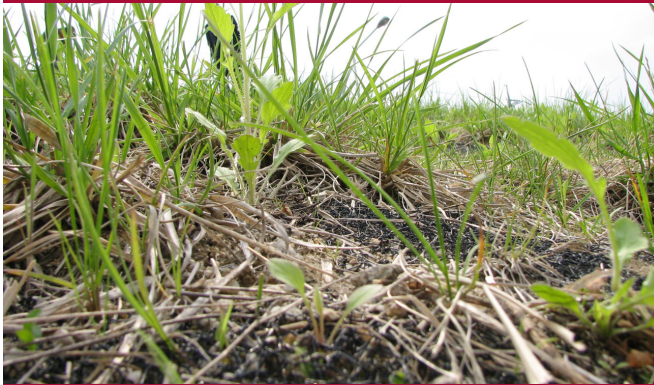
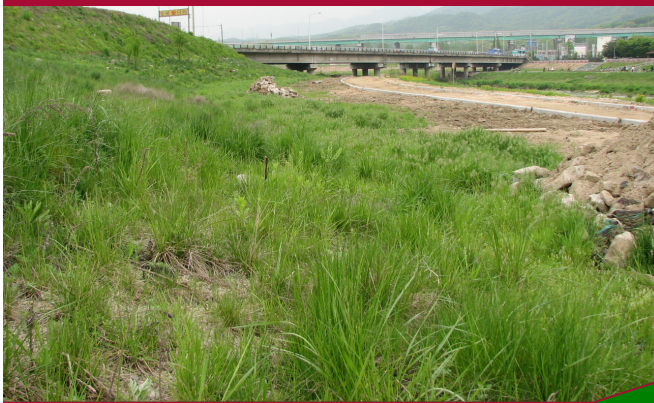
For this reason, all the slopes and embankments along the rivers are being surveyed and if necessary reconstructed. For the slopes that are above the normal watercourse, Enkamat 7018 is used. This three dimensional erosion mat has the appearance of an artificial root structure and provides permanent erosion protection to a slope. Germinating (pre-seeded) vegetation easily grows and intertwines with the Enkamat, thus resisting even greater erosion forces. Enkamat is ideal for the job, since for 80% of the year the slopes are unwetted, giving Enkamat and vegetation the opportunity to fully develop and become a very reliable anti-erosion system.
