Location:	Woudenberg, The Netherlands
Client:	Water Authority Gelderse Vallei en Eem
Design:	Water Authority Gelderse Vallei en Eem and Colbond

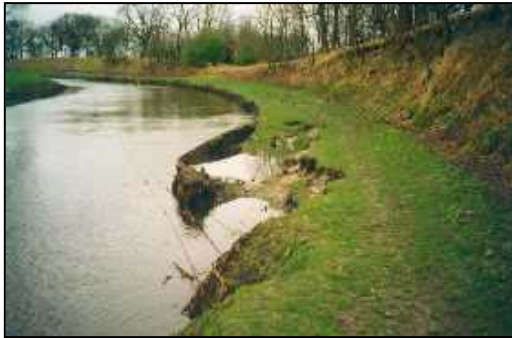
The high velocity streams occurring in the Vallei-Channel caused serious erosion damages especially in the bends of the river.

The sheet pile wall which had been constructed some years ago in such a bend suffered a very strong deformation provoked by tailwater-erosion and water veins from the upper situated dike.

As a result, the Water Authority felt compelled to restore the bank. A slope with a smaller gradient was chosen, however, this necessitated a protection against erosion.

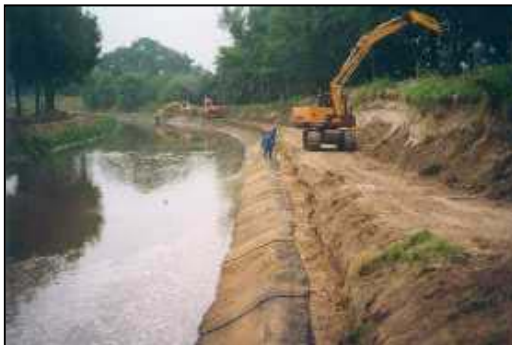
Enkamat A20/5, the three-dimensional polyamide matting, pre-filled with chippings with a bitumen binder, offered an optimum solution to this problem. The mat ensures a good protection against erosion at high velocity streams, is permeable and constitutes a nature-favourable river-bank after seeding.

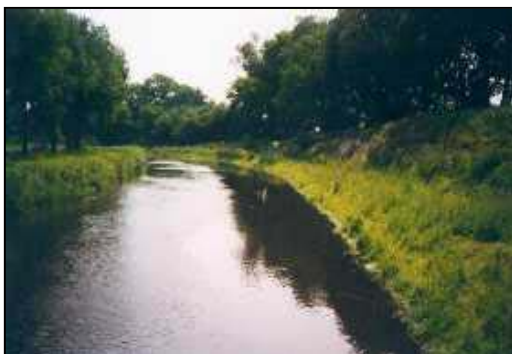
The bank was levelled and covered with seeds. Thereupon, Enkamat 20/5-roll was unrolled from the bottom towards the top and anchored at the upper side into an anchoring ditch of a spade's depth and with steel spikes.
